Pressure Reducing Fire Hose Valves

From the Desk of Lt. Rick Barnes
Division of Life Safety
Fire Code Enforcement Section

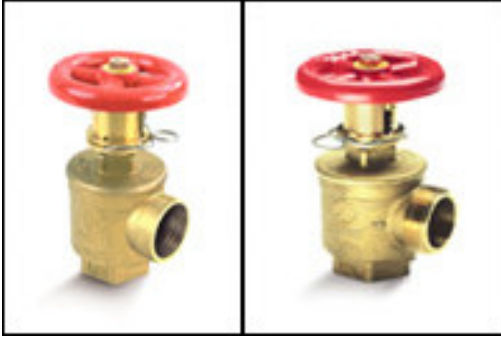
This was discovered at 7335 Wisconsin Avenue on Tuesday January 10th 2006. While conducting an operations level inspection with the crew from truck 6, pressure reducing fire hose valves were discovered on the upper floors at the standpipe risers in the stairwells. No records were found to indicate they had been properly maintained for the last 20 years.

Pressure Reducing Angle Valve made of cast brass can be adjusted to restrict pressures up to 175lbs. Locking pin device restricts full opening of valve by untrained personnel. Pin may be removed by fire personnel to allow full open valve. U.L. Listed.

1. Correct this condition at 7335 Wisconsin Avenue. Fire Code Enforcement will follow up and provide feed back to station 6 personnel. The valves will either be removed or properly tested, witnessed by fire rescue personnel, labeled for proper position and set screw location, and maintained annually. All hydraulic calculations will be required to be demonstrated to Department of Permit Services plans examiners and Fire Code Enforcement fire protection engineers.
